Service Information

Retrofit heat protection mat to coolant lines

0011450300

F06 F10 F12 F13 S63T

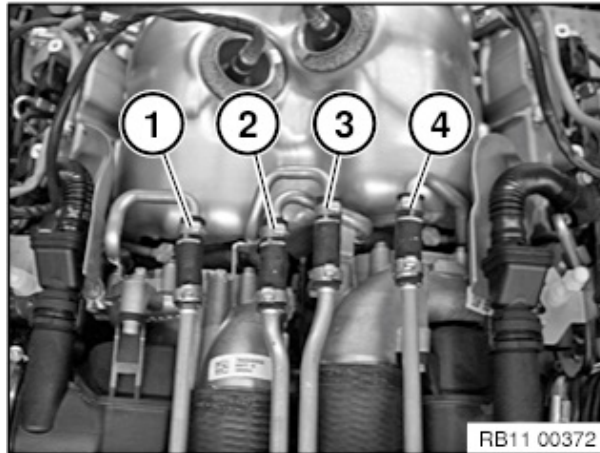
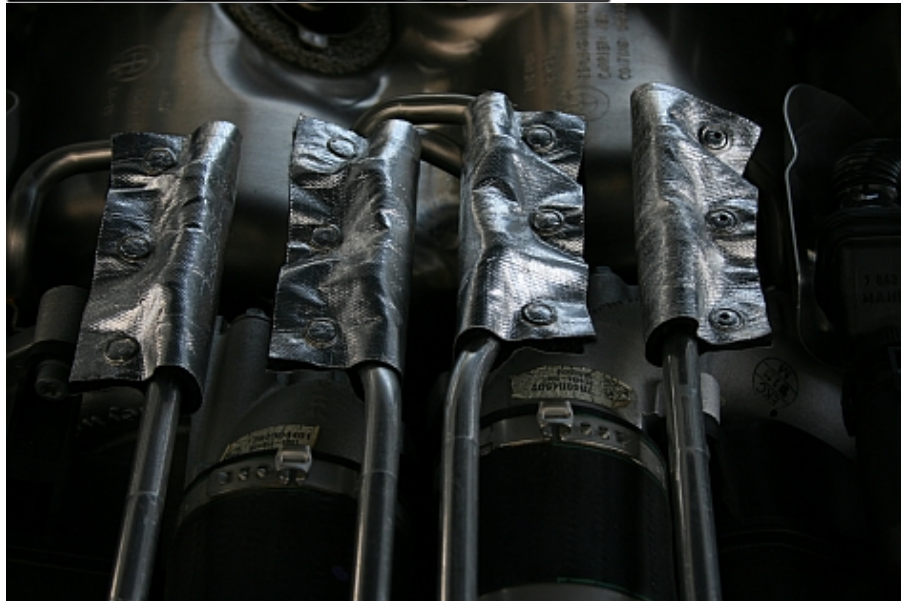
The component temperatures near the coolant lines on the exhaust turbocharger are too high. This may cause the hose elements to leak.

- To remove the engine cover, see Repair Instructions **RA 11 12 090**.
- Place one heat protection mat around each of the four hose elements of the delivery and return lines and seal them.
